B Chen Architect PLLC

November 16, 2020

Re: 82-88 Fulton Street
New York, NY
Block: 77 Lot: 24

As per your request, an interior survey of 82 Fulton Street was conducted on Thursday October 22, 2020 at approximately 12:00 pm in the afternoon. The building architect and lawyer was also present for the walk thru of all retail space. All, the retail space, are located outdoor, In an open arcade style layout, with a 3'-0" walkway, In front of the stores.

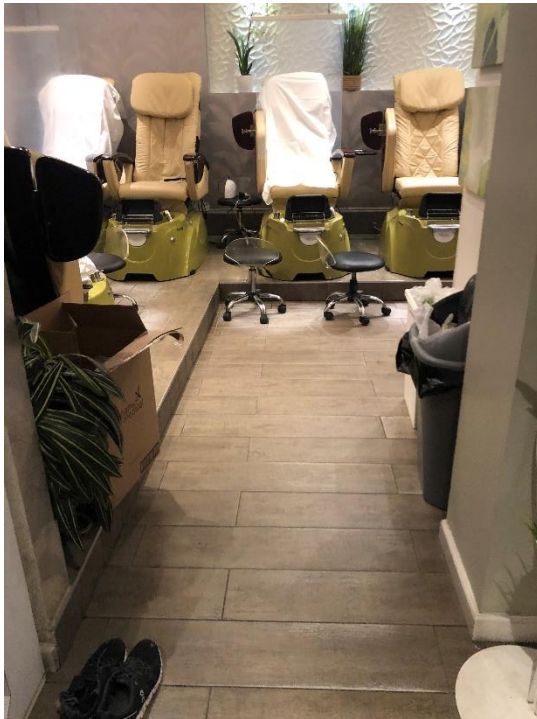
The first space which we walked thru was Affina spa, located at the corner of the building, on the first, floor level. The exterior, entry door, Is currently not ADA accessible, due to the temporary entry awning. Once the awning is removed, the entry should meet ADA approach requirement. The interior walk way of the space are fairly wide and meet ADA requirements for movement. There are two area which are not readily ADA accessible. One of the areas, In question, Is located on the left hand side of the space, next to the exterior window wall. The space consisted of a raised 6" high platform used for pedicure. The other space, which Is not ADA accessible, Is the public restroom. Due to the location of the door, in relation to the hallway, it is not ADA accessible. The approach to the restroom door is what we call a side approach. In this type of

approach, you need to have a clear hallway width of 42" min. Currently, the hallway is approximately 40", with an Inswing door into the restroom. Once inside, the restroom, the door would not be meet ADA requirement also. The door opens into a minor 40" x 30" hallway, then opening, up to a 62" x 64" restroom. In exiting the restroom, the door would be considered a frontal approach. In this type of approach, you need a clear space of 18" next to the door, which there Is currently does not exist. In terms of the

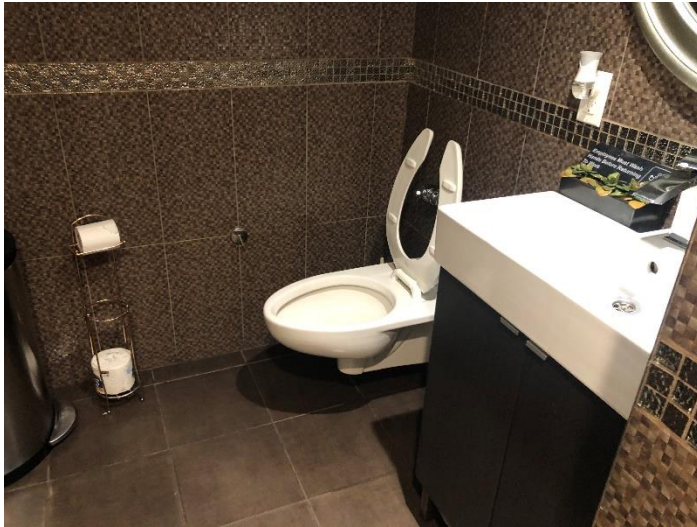
restroom, as per ADA requirement, a toilet needs to be located Inside a clear space of 60" x 56", with no other fixture within the space unless It Is a private toilet or a bathroom. Currently, there Is a lavatory within the required clear space, which does not meet ADA requirement. ``

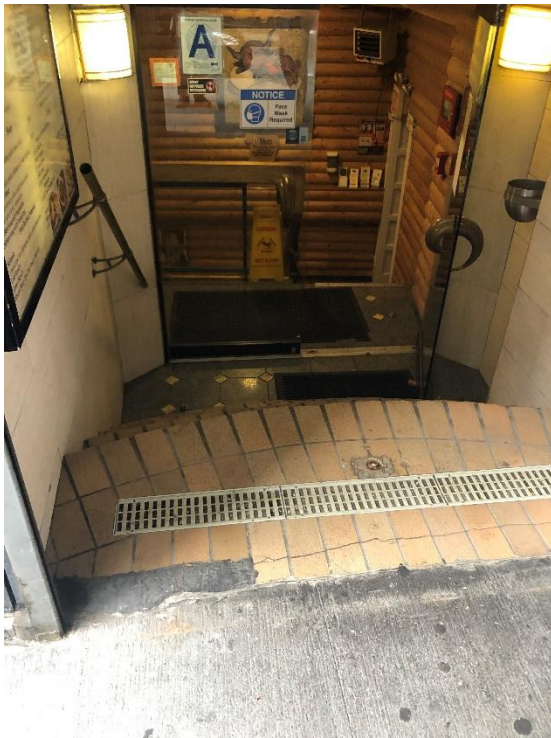
The next space which we looked at was a vacant Chinese restaurant. The approach, Into the space does not meet ADA requirements. Since the front entry door Is considered a

side approach, the walkway needs to be 42" wide minimum, but the current passageway or balcony Is only 36". In terms of the Interior, the space was vacant, with no public restroom or tables setup.

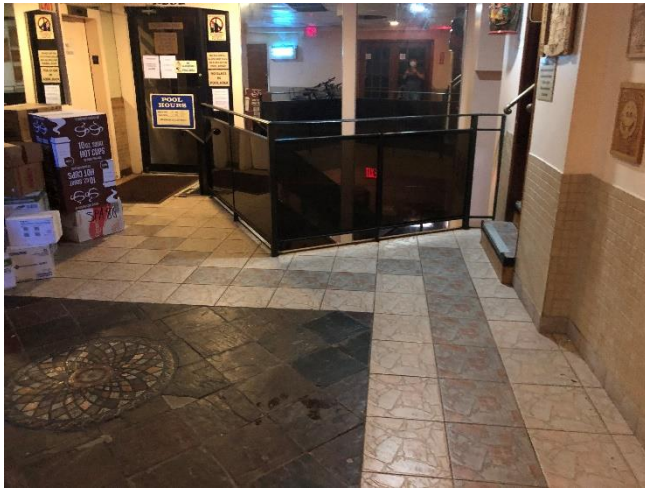
located at another level. The second stair goes down onto the sub-cellar. On the left hand, side of the lobby was a pair of double doors, which takes you Inside a sitting room. Going down the stairs to the sub-cellar there was another sitting area and a lounge which opens, up to the passageway balcony above. At the end of the lounge, there was another vestibule or small lobby area which leads you to either the men's or ladies' restroom and locker room. At the corner of the lobby was a staircase

which goes up to the main reception area and the main staircase taking you out of the space. The whole Spa Is like a split level of different spaces. The rooms itself, are mostly ADA compliant, but going from one space Into, another Is not ADA compliant, due to the many stairs which you might have, to pass thru. The space In question Is capable of being modify to be ADA compliant, but It has to be study on a plan level detail.

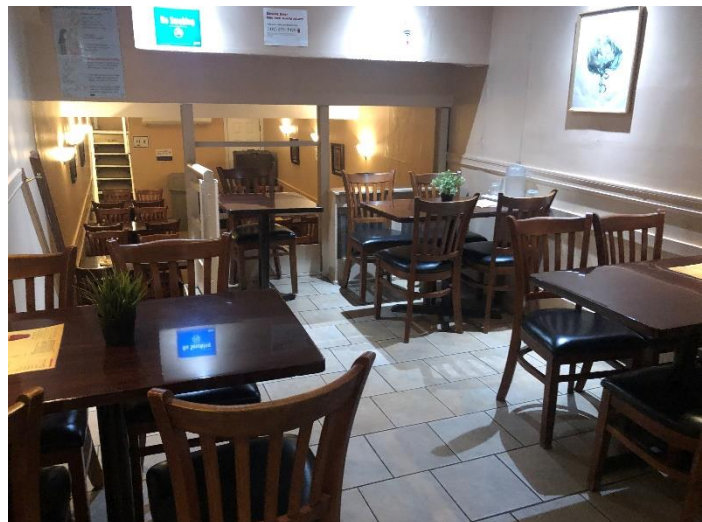
The fourth space which we Inspected Is a small dry cleaner/laundry shop. Like the other retail space, the entry door approach is not ADA compliant. The Interior public space Is ADA compliant, with enough room to maneuver around. Since It Is a full-service cleaner and not self-serve, there is no issue with the space.

The fifth space which we looked at was an Indian Tandoor restaurant. Like the previous spaces, the approach going Inside the space are not ADA compliant, due to the exterior width of the walkway. Once Inside the restaurant, the front half of the dining area Is compliant while the rear and restroom are not. In order, for a person to reach the public restroom at the rear of the restaurant, you would need to walk down a stair consisting of four steps, from the front dining area, which bring you down to a non-ADA compliant dining area. At the rear of the dining room, there Is another set of stairs going up seven steps onto a narrow landing. At the end of this landing Is the door to a 3' wide x 7' long restroom, which Is not ADA compliant.

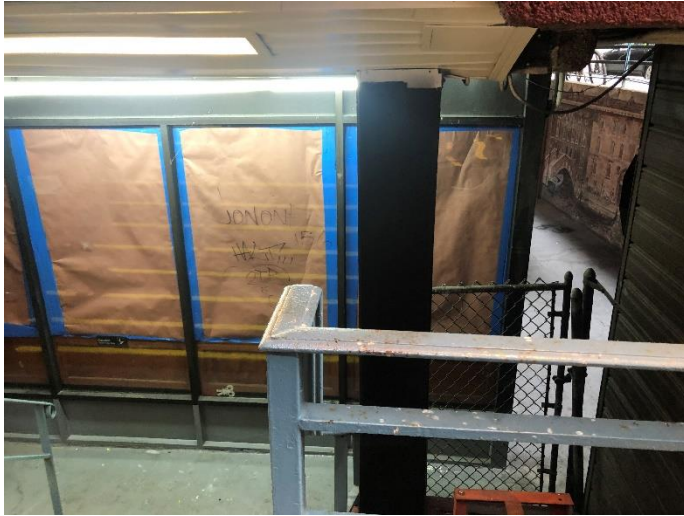
The sixth space which we looked at was a vacant retail space located on basement level

of the building. Like the other retail space, the basement level is not ADA compliant also, with access by stairs only. Since the space was vacant, an inspection of the interior was not conducted, since the ADA issue should be taken care of by any future tenant build out, when filing for work inside.

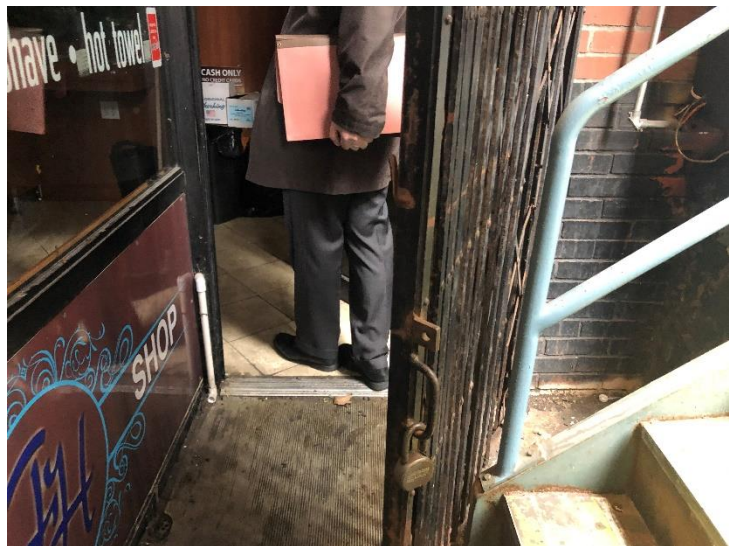
The eighth and last space is located on the left side of the spa. To gain access to the space, you need to walk down one step, onto a small landing then down another step to the exterior vestibule of the space. The space, in question, was also vacant and empty with empty display case.

In reviewing all the retail space, each one is capable of being modified to accommodate the ADA issues. There are still rooms in the arcade to expand the walkway slightly to accommodate a side approach into each retail space. Once inside each retail space, there are rooms to accommodate any public restroom and walkway if required. Even the cellar spa is capable of being made ADA compliant, when the plans are properly studied and reviewed.
